UCRL-50465

**STERLING REENTRY**

Raymond S. Guido

The Sterling Event was a 380-ton nuclear detonation conducted in the cavity remaining from the Salmon Event at a depth of 2717 ft in the Tatum salt dome near Hattiesburg, Miss.

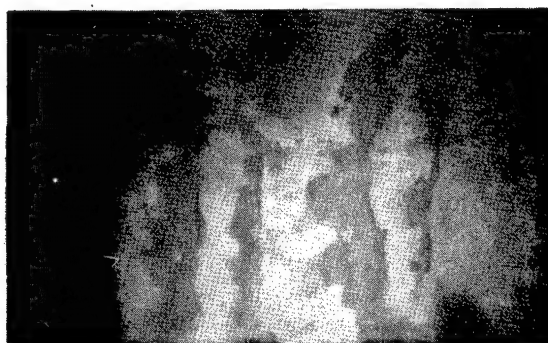
The enlarged 35mm photos shown in Figs. 10 through 12 were dark, but the roof and floor areas were visible. There were no collapsed areas distinguishable in the roof. The floor was dry and the rubble pile appeared to cover about the center one-third of the diameter of the floor.

Fig. 11. Cavity side wall at approximate depth of 2720 ft.
